Contract #: 04-0120F4Cty: SF/ALA Rte: 80 PM: 13.2/13.9File #: 99.28**WELDING INSPECTION REPORT****Resident Engineer:**Siegenthaler, Peter**Address:** 333 Burma Road**City:** Oakland, CA 94607**Report No:** WIR-025973**Date Inspected:** 03-Jul-2011**Project Name:** SAS Superstructure**OSM Arrival Time:** 700**Prime Contractor:** American Bridge/Fluor Enterprises, a JV**OSM Departure Time:** 1900**Contractor:** Zhenhua Port Machinery Company, Ltd (ZPMC) Chanxing Island **Location:** Shanghai, China**CWI Name:** N / A**CWI Present:** Yes No**Inspected CWI report:** Yes No N/A**Rod Oven in Use:** Yes No N/A**Electrode to specification:** Yes No N/A**Weld Procedures Followed:** Yes No N/A**Qualified Welders:** Yes No N/A**Verified Joint Fit-up:** Yes No N/A**Approved Drawings:** Yes No N/A**Approved WPS:** Yes No N/A**Delayed / Cancelled:** Yes No N/A**Bridge No:** 34-0006**Component:** OBG Segment**Summary of Items Observed:**

BLASTING INSPECTION**Segment 13AW**

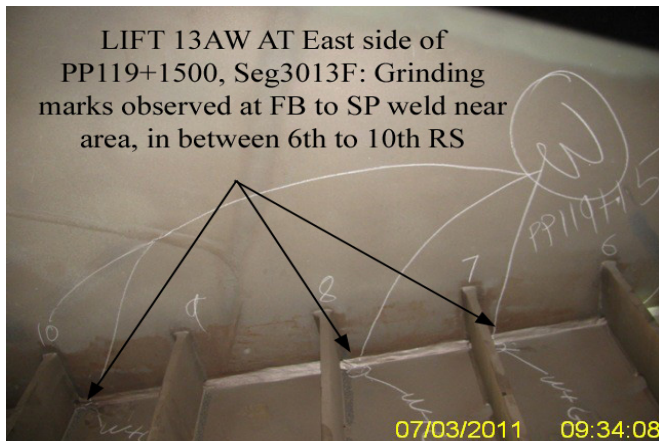
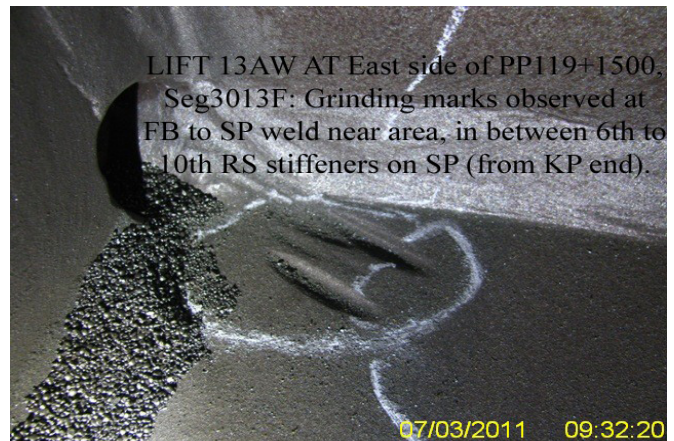
1. Seg3013F: Grinding marks observed at FB to SP weld near area(at I-rib on SP to FB) at 6th to 10th RS stiffeners on SP (from KP end). See the attached picture.
